GRAVITY SEWER REPAIR
MARINE DRIVE
CONSTRUCTION COMPLETION REPORT

PREPARED
OCTOBER 9, 2001

CITY OF BLAINE, PUBLIC WORKS DEPARTMENT
1200 YEW AVENUE
BLAINE, WA 98230

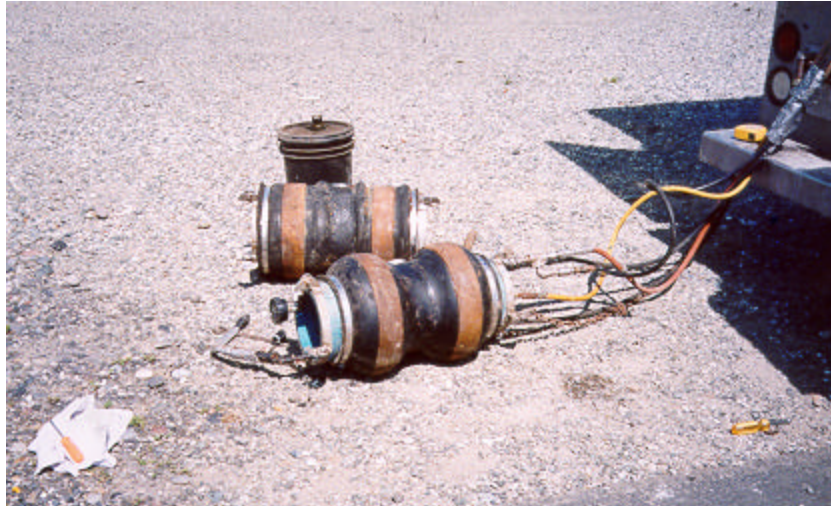
Pipe joints were sealed by epoxy injection followed by a pressure test to confirm the repair. Figure 1. below shows the equipment that GELCO used to make these joint improvements.

Figure 1. - Joint seal and pressure test device (August 2001).
Photo by Jon Walter

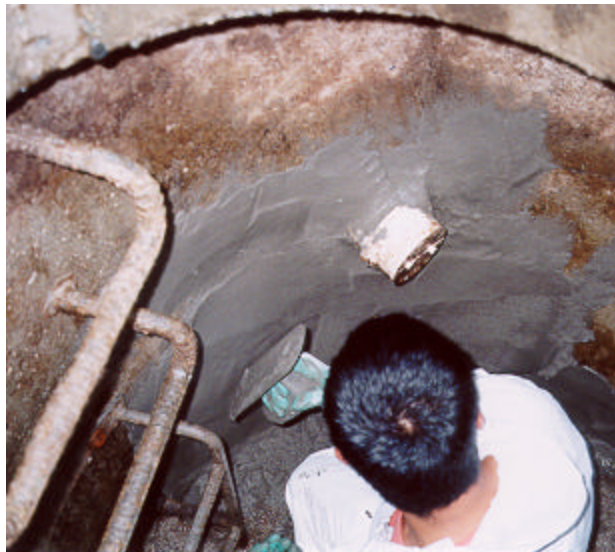
The manhole patching that GELCO completed involved trowel application of a cementacious mastic material as shown in Figure 2 below.

Figure 2. – Trowel application of patching material in manhole on Marine Drive (August 2001).
Photo by Jon Walter

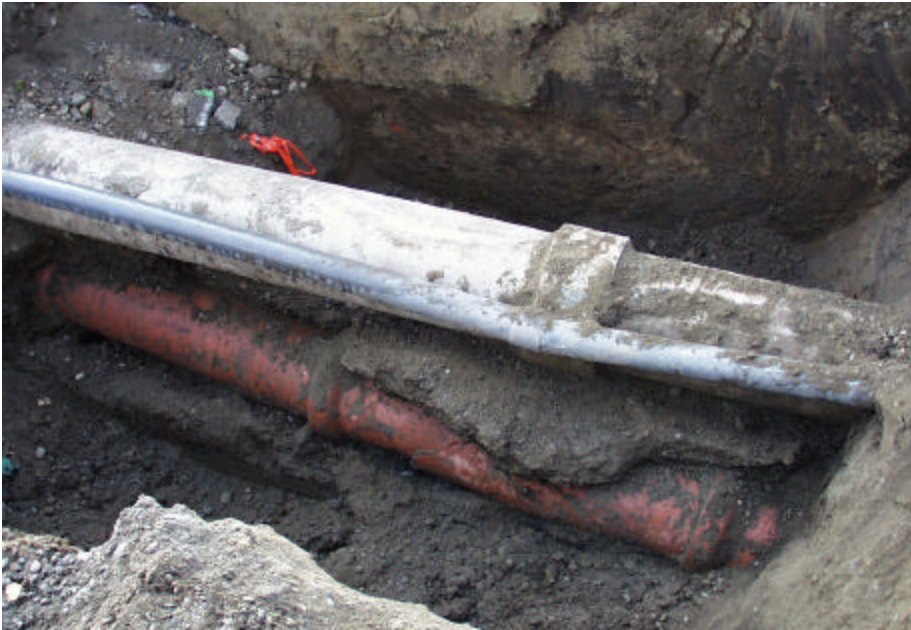
The photograph in Figure 3 below shows a water pipe (gray) and parallel electrical conduit above a broken segment of clay sewer pipe (red) below. We determined that the damage to one of the sewer pipe section was caused in part by a large concrete block between the pipes, probably installed to support the water pipe joint above. The concrete was removed and the damaged pipe replaced with new PVC pipe (Figure 4). The excavation was then filled with pea gravel. In one of the other areas repaired by Public Works, a remnant of wooden pilings (probably from an old trolley line) was found directly below the clay sewer pipe causing differential settlement and damage to the pipe. Prior to replacing the broken pipe section, the public works crew removed the top 12" or so of the remnant piling. Roadside surfaces were restored with compacted crushed gravel.

Figure 3.
On Marine Drive,
broken 12"
diameter clay
sewer pipe below
water pipe and
electrical conduit.
(September 2001)
*Photo by Jon
Walter*

Pipeline replacement was completed by City of Blaine, Public Works by open cut excavation. Broken clay and concrete pipe sections were removed and replaced with new PVC-900 pipe. The ends of the new pipe were fastened to the existing pipe with banded (FERNCO brand) couplings.

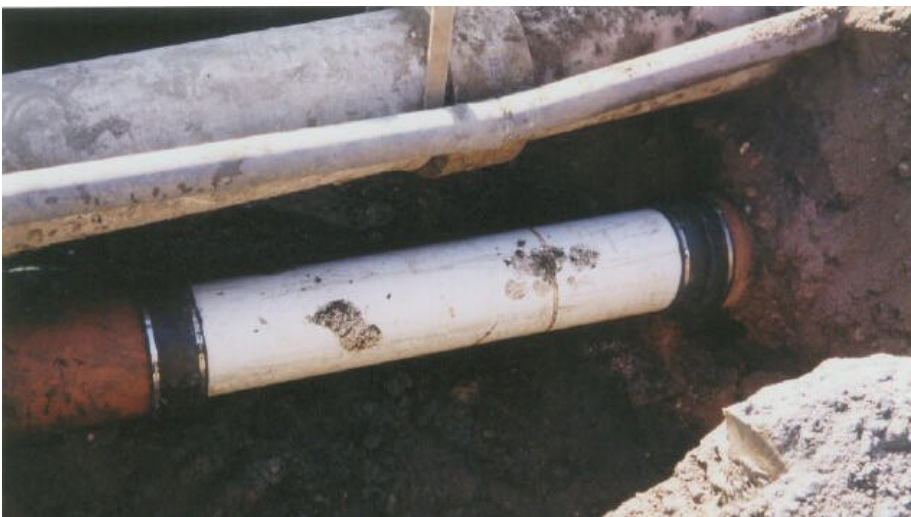
Figure 4.
On Marine Drive,
12" sewer pipe
repairs completed
by Public Works
(September 2001)
*Photo by Jon
Walter*
